CR-170893

TECHNICAL NOTE

Contract	NAS8-32982	Date	6 August 1982	Doc.	LMSC-HREC TN D867576
Title	RESULTS OF TESTS OF WEATHERED K5NA CLOSEOUT MATERIAL IN THE MSFC HOT GAS FACILITY

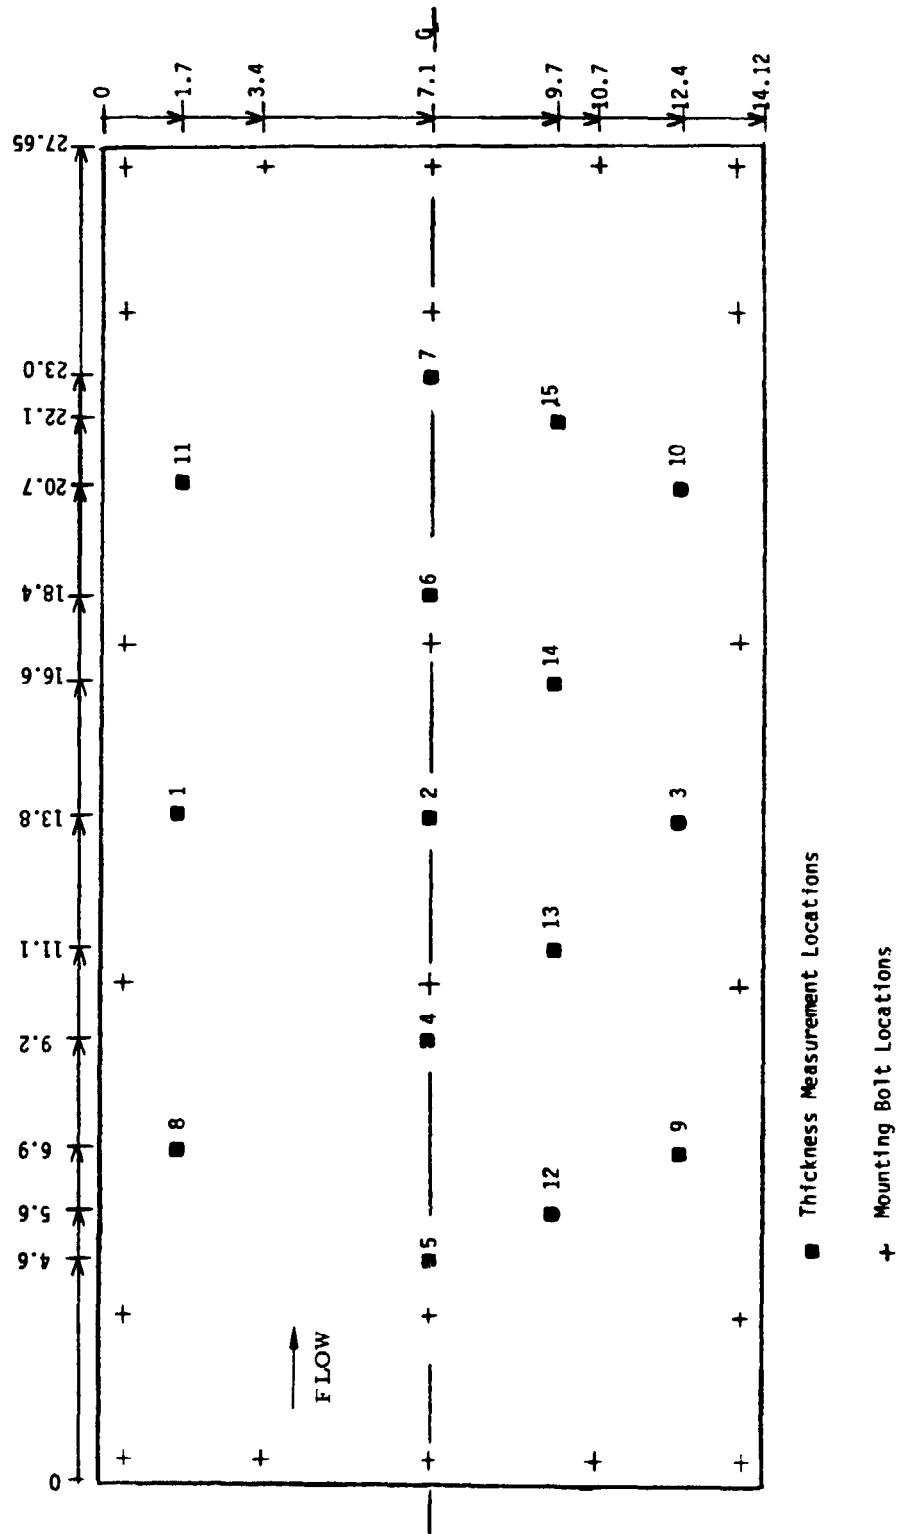
Fig. 14 - Location at Which Thickness Measurements Were Made

Tables 2 through 7 show the pretest, post-test and recession data for all panels. Figure 14 shows the locations at which thickness measurements were made.
